Property Inspection Report

23145 Charitan Blvd.
Columbia, Missouri 65201

Prepared for: Melania Westwood

Prepared by: Spradling Home Inspections, LLC

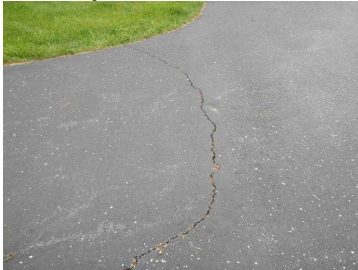
1. Acceptable **Driveway:** Asphalt - A wide crack in the asphalt driveway is present, close to the detached garage. This will permit water intrusion, and damage from freeze/thaw cycles is likely. Recommend filling and sealing with approved materials.

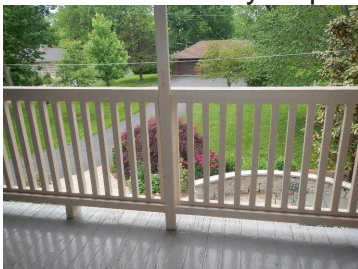
6. Acceptable **Balcony:** Treated wood - The safety railing on the balcony is shorter than current building standards. Recommend installing additional rails to increase the height to at least 42 inches by a qualified contractor.

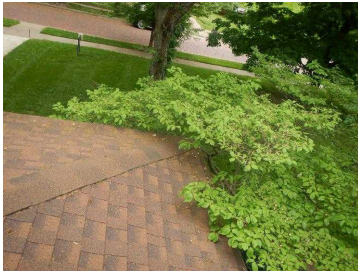
Vegetation: Mulched beds and shrubs - Tree limbs over hang the roof and should be cut back. Recommend at least 8 feet of clearance after limbs are cut.

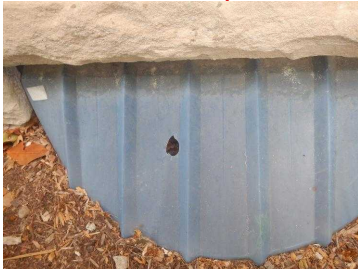
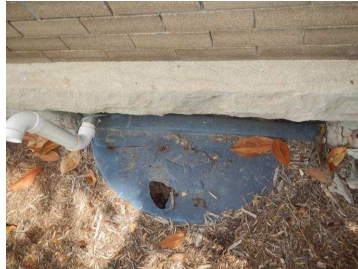
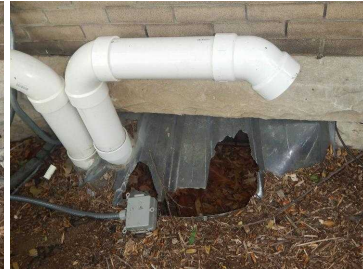
Window Wells: Covered - Several damaged window well covers were observed. Recommend replacement as needed.

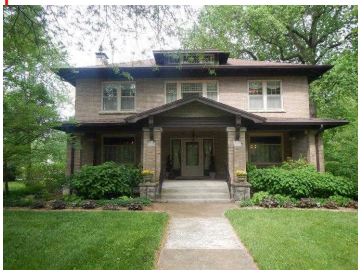
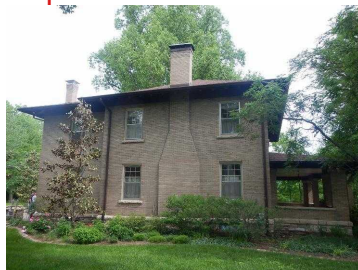
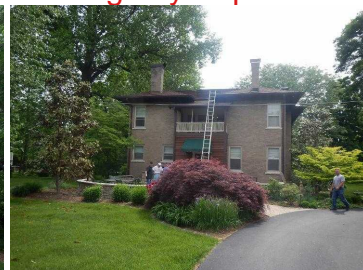
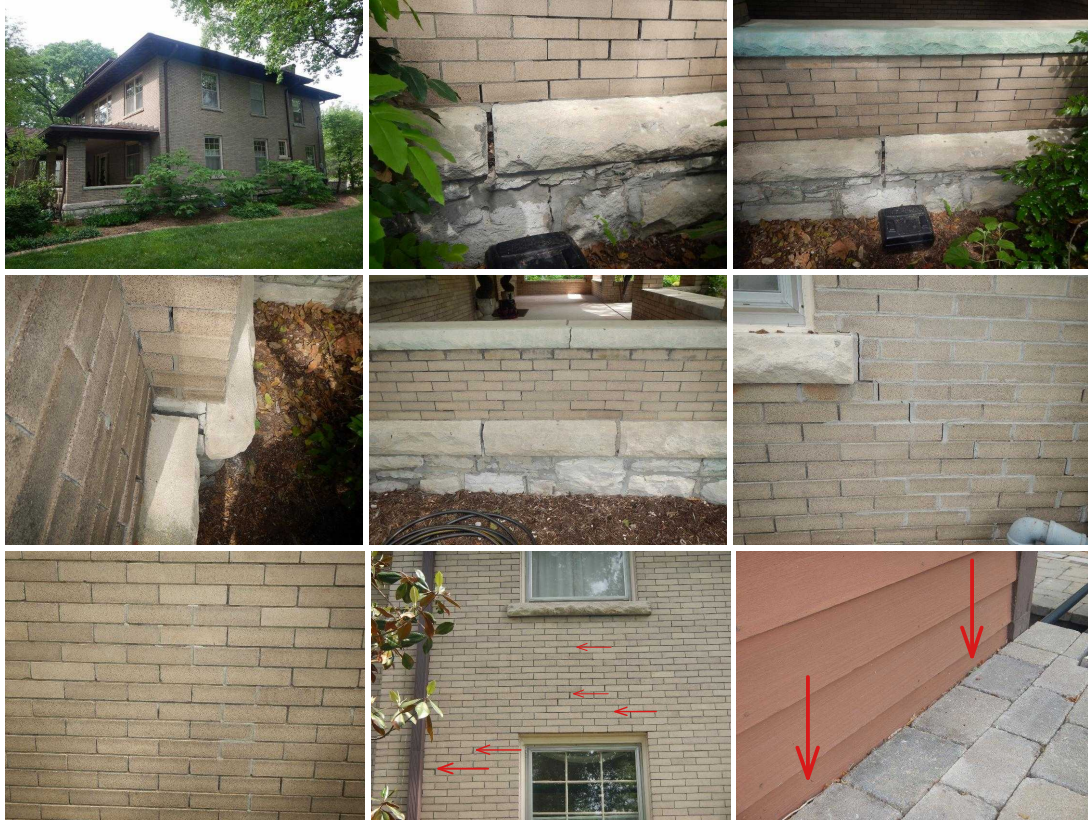
Type: Brick veneer, cedar lap siding and stone foundation blocks - Missing mortar and soft mortar was observed on all sides of the home's brick veneer and stone foundation. This condition will make the brick veneer prone to leak, and subsequent damage to the veneer and to the framing behind is likely. Previous repair attempts were noted. Some of the repairs have re cracked, and most are easily seen. Recommend further review by a qualified masonry contractor, and tuck point to repair as needed.

The paver brick stoop in the rear is installed on top of the wood lap siding. This will be prone to rot. Recommend repairs to minimize water damage by a qualified contractor.

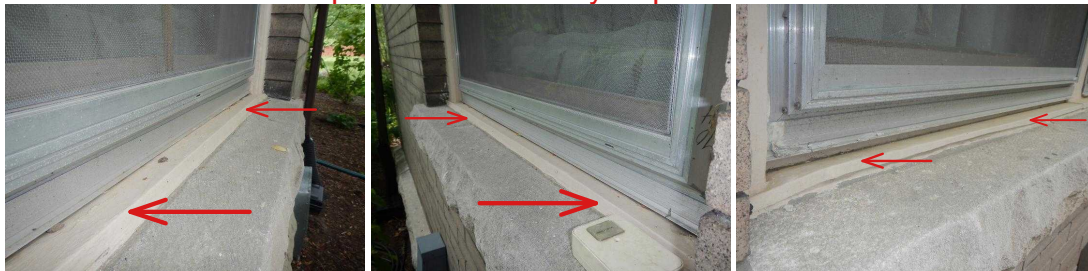
Windows: Wood single hung - The metal wrap on several window sills slopes back towards the window. This will direct rain towards the house, rather than away from the house. Recommend repairs as needed by a qualified contractor.

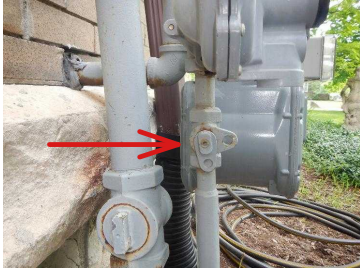
Hose Bibs: Rotary valves**Gas Meter:** Exterior surface mount at side of home**Main Gas Valve:** Located at gas meter - In the photo, the arrow points to the gas shut off valve for the entire house. This would need a wrench or large pliers to turn off. When the holes line up, the gas supply is turned off.

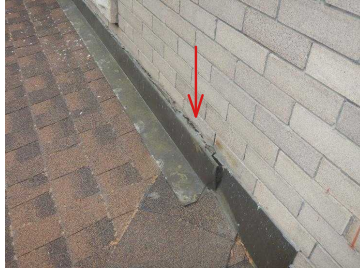
Flashing: Galvanized, aluminum and rubber - Loose counter flashing was observed along the wall/roof intersection above the front porch. This will be prone to wind damage and to leak. Recommend repairs by a qualified contractor.

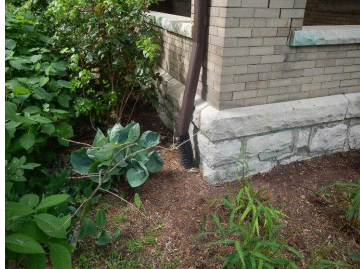
Leader/Extension: Buried plastic - Recommend locating the discharge end of the buried downspout extension tubes, and keeping them clear of mud and debris.

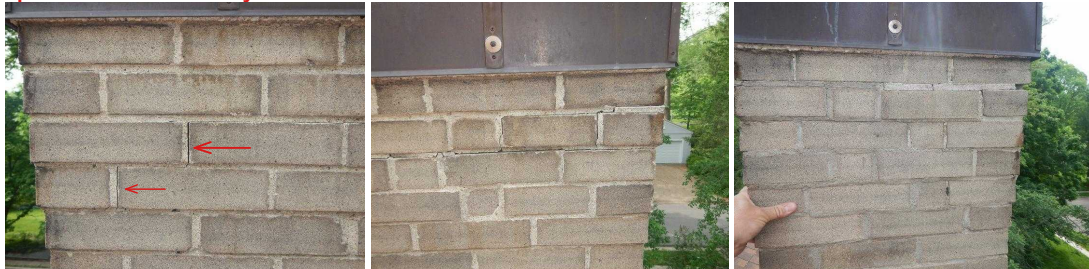
**South slope Chimney**

Chimney: Brick - Missing mortar and cracks were noted on the roof level chimney faces. Soft mortar was noted in most of the mortar joints. Moisture intrusion is likely in these areas, and subsequent damage is likely. Recommend tuck point repairs by a qualified masonry contractor.

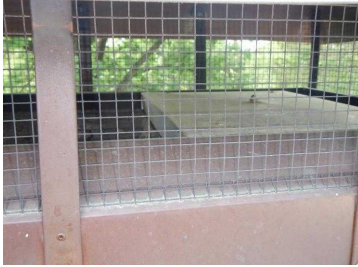
Flue/Flue Cap: Flue was inspected by others (Chimney Safe) - Spring loaded flue top dampers are not recommended for use with gas fireplace logs. Recommend removal.

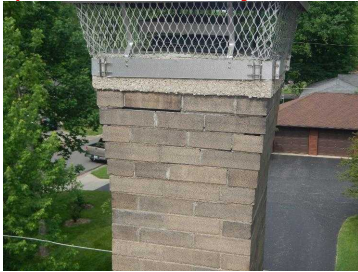
15. Marginal **Chimney:** Brick - Missing mortar and cracks were noted on the roof level chimney faces. Soft mortar was noted in most of the mortar joints. Moisture intrusion is likely in these areas, and subsequent damage is likely. Recommend tuck point repairs by a qualified masonry contractor.

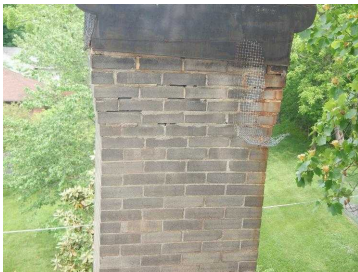
18. Marginal **Chimney:** Brick - Missing mortar was noted on the roof level chimney faces. Soft mortar was noted in most of the mortar. Moisture intrusion is likely in these areas, and subsequent damage is likely. Recommend tuck point repairs by a qualified masonry contractor.

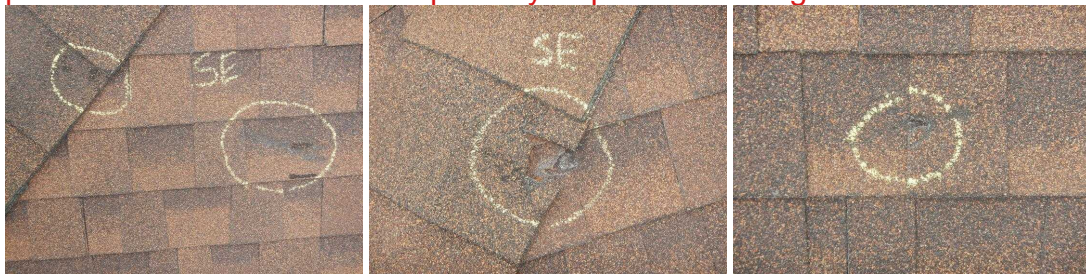
6. Marginal **Roof:** Laminated fiberglass and asphalt composition shingles - Several damaged shingles are present, at the southeast corner of the garage roof. Some of these will be prone to leak. Recommend repairs by a qualified roofing contractor.

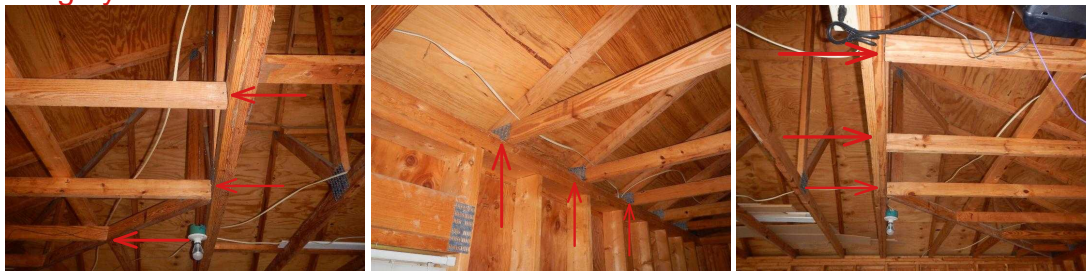
7. Marginal **Roof Structure:** 2x4 Engineered Wood Truss - Several field modified trusses are present at the north and south ends of the roof framing. Any cuts to an engineered truss should be evaluated by a licensed structural engineer to ensure structural integrity.

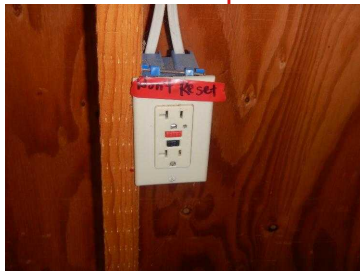
12. Defective **Electrical:** 110 VAC GFCI - One of the GFCI electrical outlets won't reset. Recommend replacement by a licensed electrician.

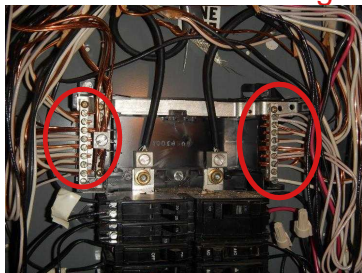
1. **Service Size Amps:** 150 Amps **Volts:** 110-220 VAC
 2. Acceptable **Service:** Copper
 3. Marginal **120 VAC Branch Circuits:** Copper - The ground and neutral wires in the electric sub panel are terminated on the same bus bars. In a sub panel, the neutral wires and ground wires should be separated, and the neutral bus should be insulated from the metal enclosure. The ground bus should be bonded to the enclosure.

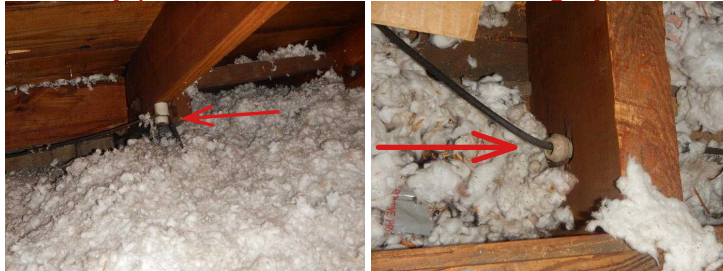
1. **Method of Inspection:** In the attic
2. Acceptable **Roof Framing:** 2x6 Rafter and king post braces
3. Acceptable **Sheathing:** Dimensional wood
4. Acceptable **Ventilation:** Gable vents
5. Acceptable **Insulation:** Blown in fiberglass
6. Acceptable **Insulation Depth:** 10-12 inches
7. Defective **Wiring/Lighting:** 110 VAC - Live knob and tube wiring was observed in the attic in several areas, and is partially covered by insulation. This wiring is considered outdated and a latent safety hazard. Recommend replacement of all knob and tub wiring with currently produced branch circuit wiring by a licensed electrician.

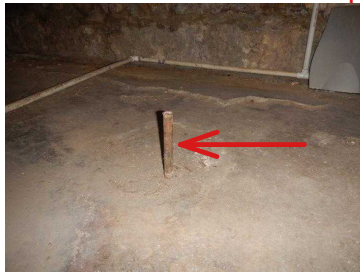
1. Acceptable **Ceiling:** Exposed framing
2. Marginal **Walls:** Exposed foundation walls
3. Marginal **Floor:** Concrete - Abandoned steel piping sticks out of the floor about 6 inches, next to the boiler. This is a tripping hazard. Recommend grinding off flush with the floor.

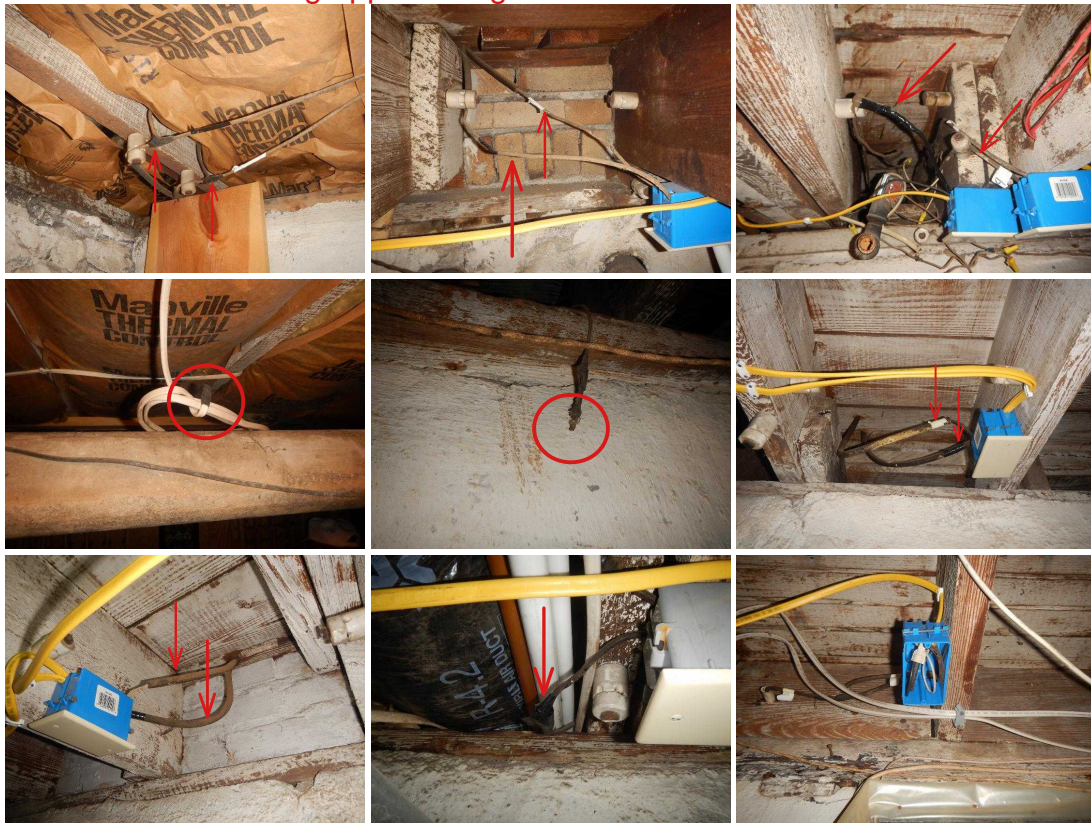
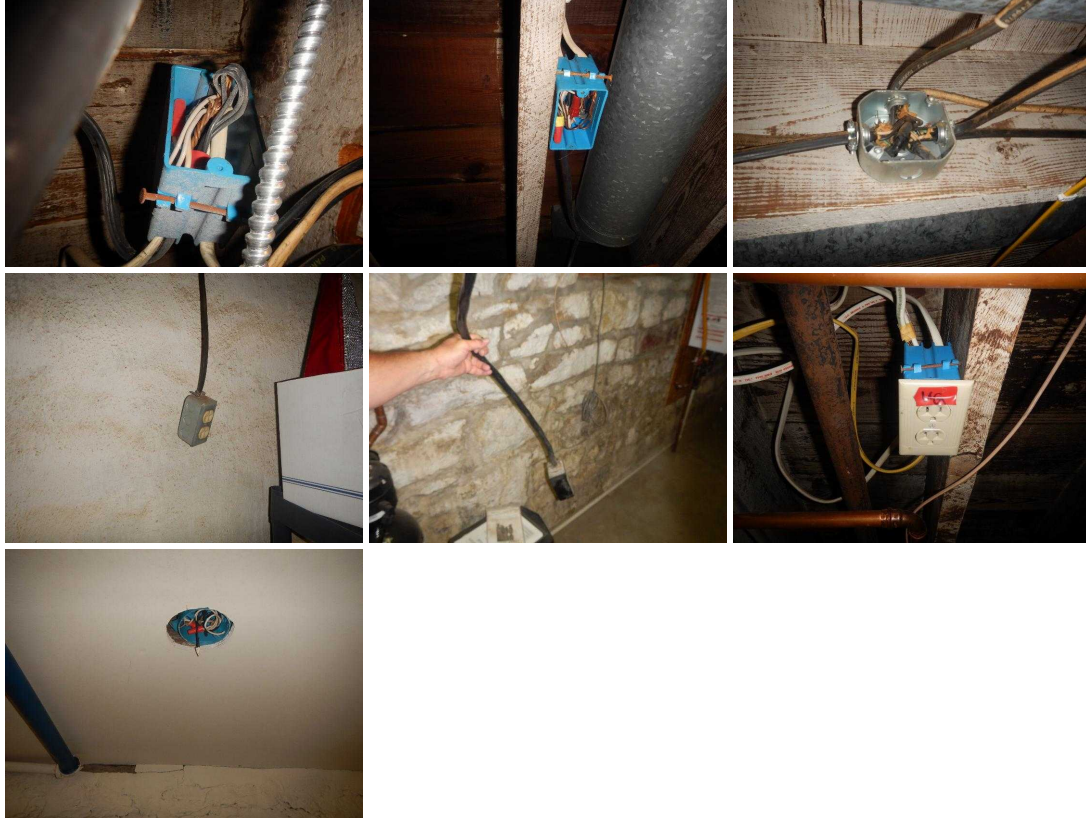
Electrical: 110 VAC outlets and lighting circuits - Live knob and tube wiring was observed in the basement ceiling in several areas, and is partially covered by insulation. This wiring is considered outdated and a latent safety hazard. Recommend replacement of all knob and tub wiring with currently produced branch circuit wiring by a licensed electrician.

Exposed wire splices were observed in the basement. Flying splices are an inherent safety hazard. Recommend enclosing in an approved junction box.

Numerous open junction boxes were observed. Recommend installing approved cover plates as needed.

Improperly terminated branch wiring was observed in the basement ceiling. This is a potential safety hazard. Recommend enclosing in an approved termination box.

Unsecured electrical outlets were observed. These are a safety hazard. Recommend anchoring to the wall as needed.

Ungrounded 3 prong outlets were observed at 1 location in this area. This is a safety hazard. Recommend repairs as needed by a licensed electrician.

Several incomplete light fixture installations were observed in the basement. Recommend installing approved light fixtures as needed.

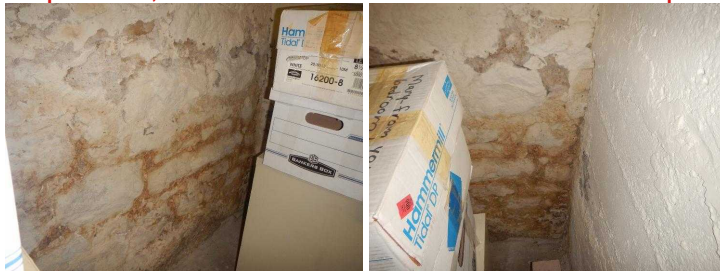
Moisture Location: Previous moisture penetration noted - **Staining along the bottom of the wall opposite the basement stairs was noted. The area was dry at the time of the inspection, and no other evidence of moisture penetration was observed.**

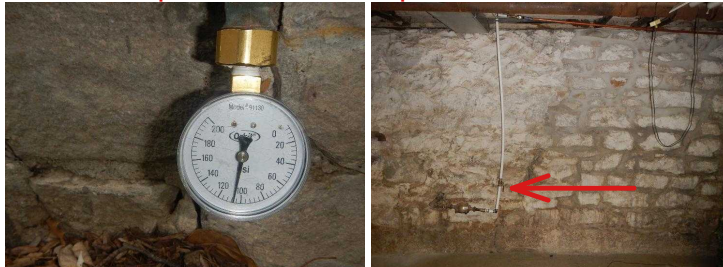
- 1. Acceptable **Service Line:** Galvanized steel - The majority of the water service line is buried below grade, and the material used is not known. The visible portion is galvanized steel.
- 2. Defective **Main Water Shutoff:** Basement - **Water pressure was measured at nearly 110 PS I. This is excessive, and is likely to cause damage to the plumbing system, and components. Recommend installation of a water pressure regulator valve and adjusting the the water pressure as needed to lower the water pressure to 40 to 60 PS I.**

In the 2nd photo, the arrow points to the main water shut off valve.

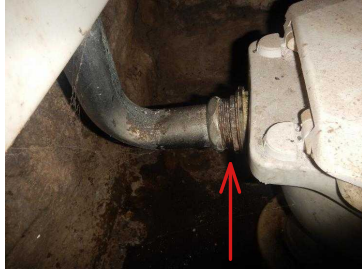
Toilets: Securely mounted - A leak was observed between the tank and the bowl. Recommend repairs by a qualified plumbing contractor.

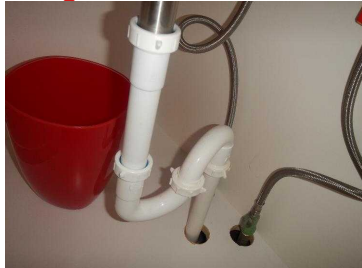
Faucets/Traps: Water pressure and drainage adequate - S type drain traps are present. These are known to siphon dry during use, and may allow sewer gas into the living area. These are not longer approved. Recommend replacement with a P trap.

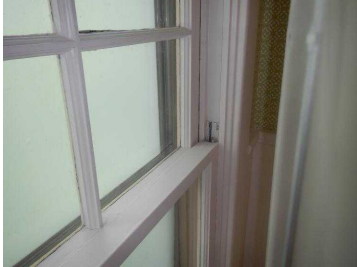
Windows: Wood single hung - The cords for the counter balance system are missing. Windows that slam shut are a safety hazard. Recommend repairs as needed.

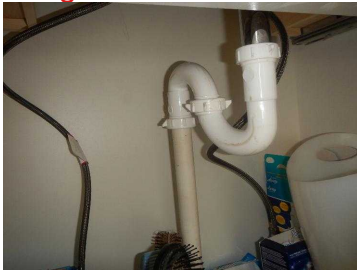
Faucets/Traps: Water pressure and drainage adequate - S type drain traps are present. These are known to siphon dry during use, and may allow sewer gas into the living area. These are not longer approved. Recommend replacement with a P trap.

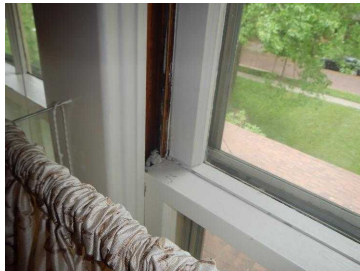
| 6. Marginal | Windows: Wood single hung - The cords for the counter balance system are missing. Windows that slam shut are a safety hazard. Recommend repairs as needed. |

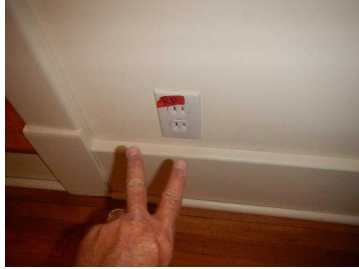
| 7. Defective | Electrical: 110 VAC outlets and lighting circuits - Reversed polarity was observed at 2 electric outlets in this room. This is a safety hazard. Recommend repairs as needed by a licensed electrician. |

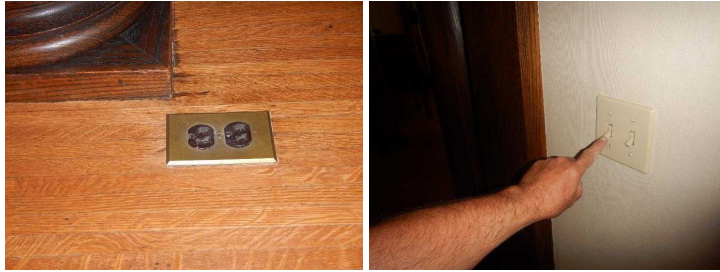
Electrical: 110 VAC outlets and lighting circuits - The electric outlets in the floor are not of a type approved for face up installation. This is a safety hazard. Recommend replacement by a licensed electrician.

A "mystery switch" was noted in this room. Recommend asking the seller about it's function.

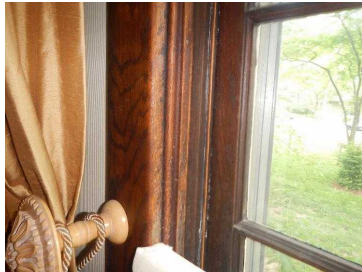
Windows: Wood single hung - The cords for the counter balance system are missing. Windows that slam shut are a safety hazard. Recommend repairs as needed.

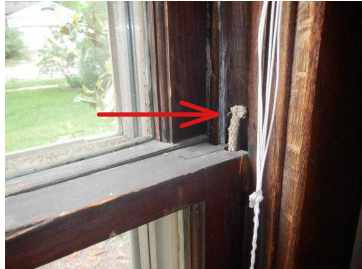
Windows: Wood single hung - The cords for the counter balance system are missing. Windows that slam shut are a safety hazard. Recommend repairs as needed.

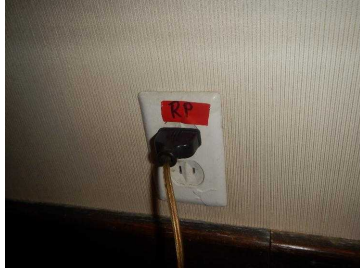
Electrical: 110 VAC outlets and lighting circuits - Reversed polarity was observed at 1 electric outlet in this room. This is a safety hazard. Recommend repairs as needed by a licensed electrician.

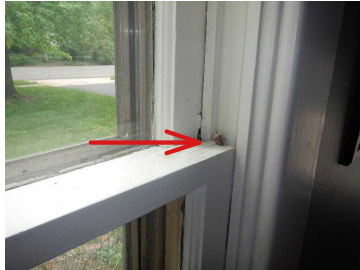
Windows: Wood single hung - The cords for the counter balance system are missing. Windows that slam shut are a safety hazard. Recommend repairs as needed.

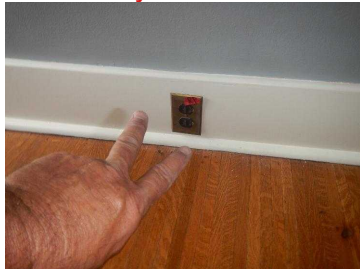
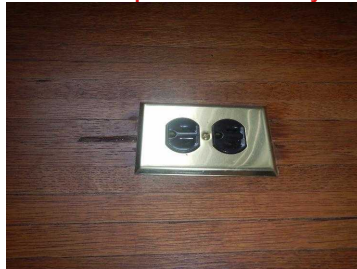
Electrical: 110 VAC outlets and lighting circuits - Reversed polarity was observed at 2 electric outlets in this room. This is a safety hazard. Recommend repairs as needed by a licensed electrician.

The electric outlets in the floor are not of a type approved for face up installation. This is a safety hazard. Recommend replacement by a licensed electrician.

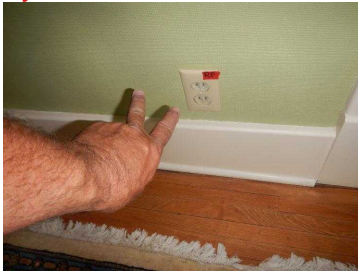
35. Marginal **Windows:** Wood single hung - The cords for the counter balance system are missing. Windows that slam shut are a safety hazard. Recommend repairs as needed.
36. Defective **Electrical:** 110 VAC outlets and lighting circuits - Reversed polarity was observed at 2 electric outlets in this room. This is a safety hazard. Recommend repairs as needed by a licensed electrician.

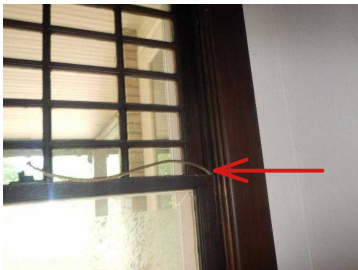
1. Acceptable **Closet:** 2 Large
2. Acceptable **Ceiling:** Plaster, painted
3. Acceptable **Walls:** Plaster, painted
4. Acceptable **Floor:** Ceramic tile
5. Acceptable **Doors:** Solid wood entry door
6. Marginal **Windows:** Wood single hung - The cords for the counter balance system are missing. Windows that slam shut are a safety hazard. Recommend repairs as needed.

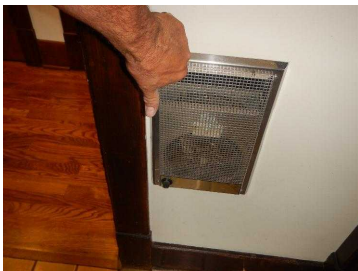
7. Defective **HVAC Source:** Wall mounted electric heater - The fan on the electric heater does not work. This is a safety hazard. Recommend repairs or replacement by a qualified electrician.
