Home Inspection Report

30081 Greenwood Town
Columbia, Missouri 65201

Prepared for: Melanie Westwood

Prepared by: Spradling Home Inspections, LLC
1500 South Rustic Rd.
Columbia, Missouri 65201

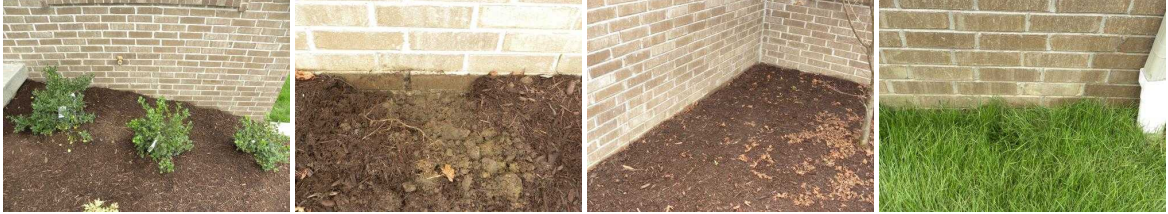
- 1. Acceptable Driveway: Concrete
- 2. Acceptable Walks: Concrete
- 3. Acceptable Steps/Stoops: Concrete
- 4. Acceptable Patio: Concrete
- 5. Acceptable Deck: Treated wood floor framing and cedar floorboards, support posts and railings
- 6. Marginal Grading: Minor slope There is soil piled too high against the brick veneer in the front of the house, and in a couple of small areas on the sides. This is conducive for termite activity. Recommend removing soil where needed to expose 2-4 inches of the concrete foundation.

1. Grading: Minor slope **There is soil piled too high against the brick veneer in the front of the house, and in a couple of small areas on the sides. This is conducive for termite activity. Recommend removing soil where needed to expose 2-4 inches of the concrete foundation.**

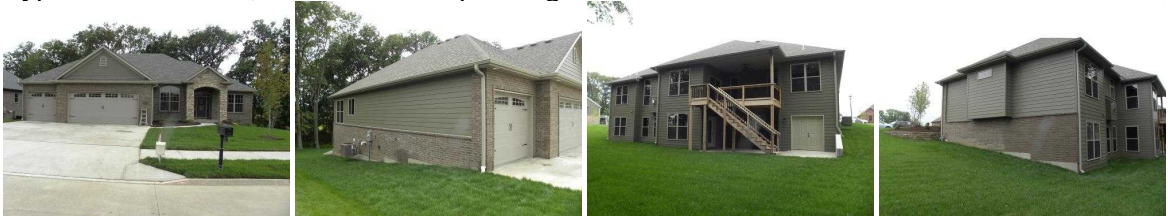
- 1. Acceptable Type: Brick veneer, cement fiber lap siding

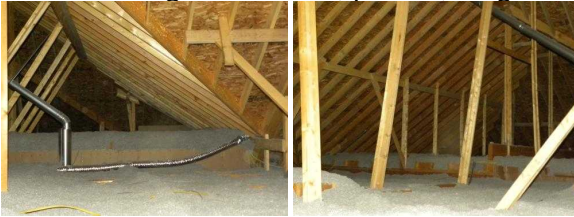
1. Method of Inspection: From the attic access
2. Acceptable Roof Framing: 2x6 rafters, purlins, diagonal bracing, rafter ties
