Property Inspection Report

23145 Charitan Blvd.
Columbia, Missouri 65201

Prepared for: Melania Westwood

Prepared by: Spradling Home Inspections, LLC

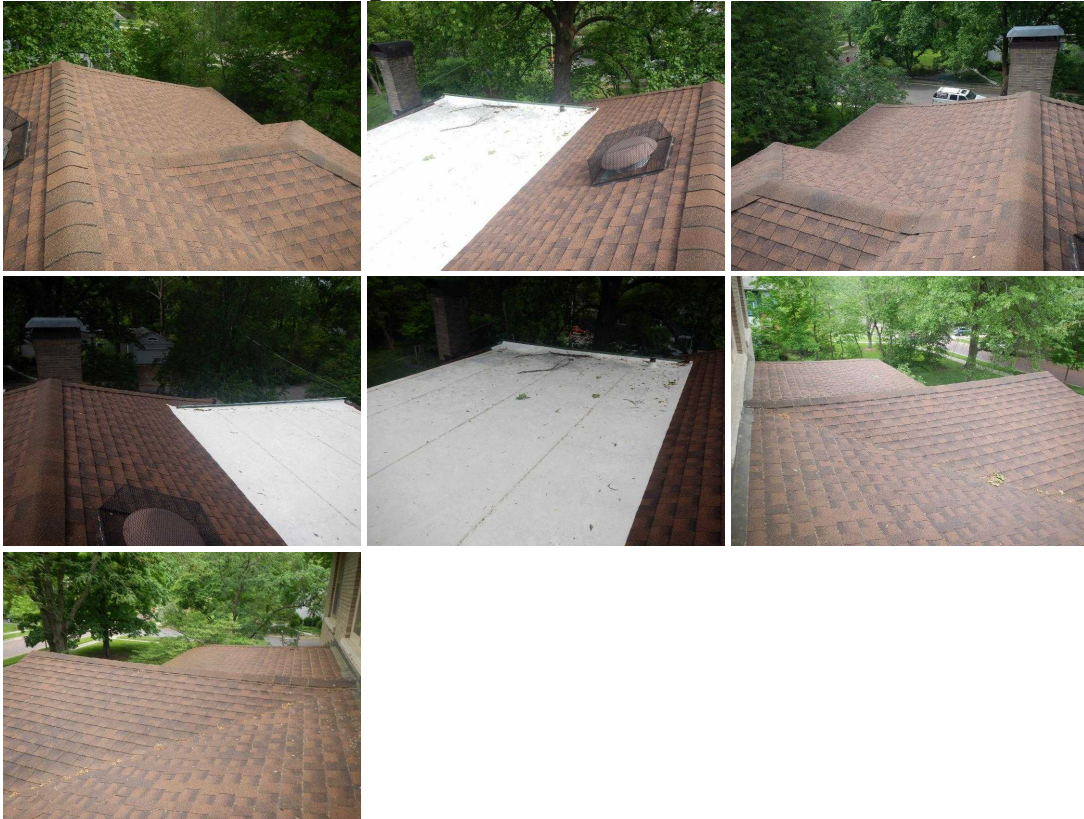
- 1. **Method of Inspection:** The roof was inspected from the roof surface
- 2. Acceptable **Material:** Laminated fiberglass and asphalt composition shingles and EPDM rubber

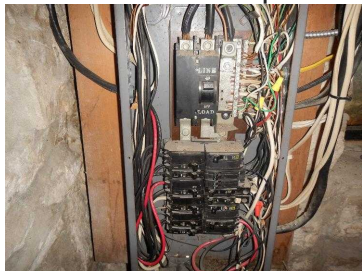
Basement Electric Panel

9. Acceptable **Manufacturer:** Square D

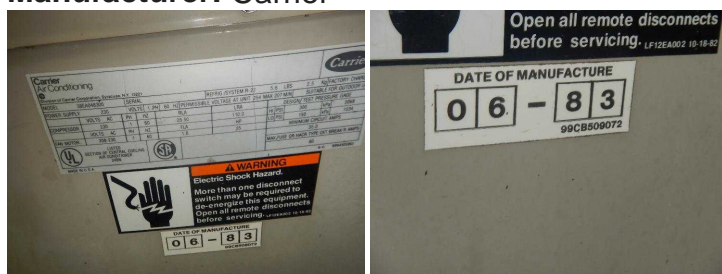
North side, left AC System

1. Acceptable **A/C System Operation:** The air-conditioning system was operated and performed satisfactorily
2. Acceptable **Condensate Removal:** PVC tubing into a surface drain
3. Marginal **Exterior Unit:** Pad mounted - The outside unit is in service longer than the national average, and may need repair or replacement within the next few years. With equipment this age, it is recommended that a qualified HVAC contractor evaluate the unit during warmer weather and make recommendations for maintenance or repair.
4. **Manufacturer:** Carrier

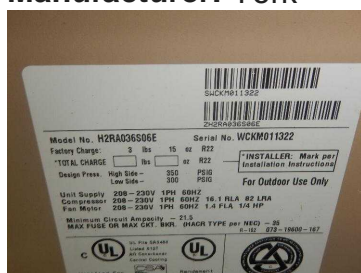
North side, right AC System

11. Acceptable **A/C System Operation:** The air-conditioning system was operated and performed satisfactorily
12. Acceptable **Condensate Removal:** PVC tubing
13. Marginal **Exterior Unit:** Pad mounted - The outside unit is in service longer than the national average, and may need repair or replacement within the next few years. With equipment this age, it is recommended that a qualified HVAC contractor evaluate the unit during warmer weather and make recommendations for maintenance or repair.
14. **Manufacturer:** York

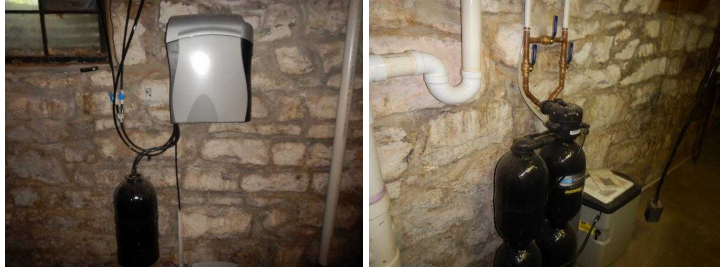
- 3. Acceptable **Water Lines:** Galvanized, Copper and Pex plastic - The water softener system was not tested or evaluated as part of this home inspection.

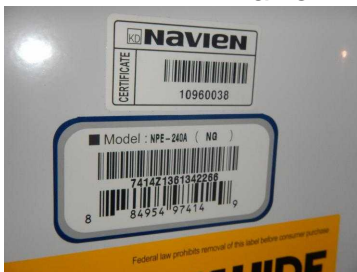
9. **Manufacturer:** Navien

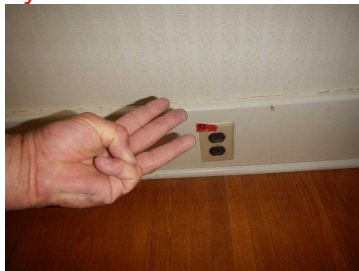
Upper level southeast Bedroom

- 10. Acceptable **Closet:** Large
- 11. Acceptable **Ceiling:** Plaster, painted
- 12. Acceptable **Walls:** Plaster, wallpaper
- 13. Acceptable **Floor:** Hardwood
- 14. Acceptable **Doors:** Solid wood
- 15. Acceptable **Windows:** Wood single hung
- 16. Defective **Electrical:** 110 VAC outlets and lighting circuits - Reversed polarity was observed at 3 electric outlets in this room. This is a safety hazard. Recommend repairs as needed by a licensed electrician.

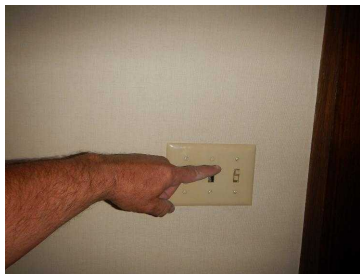
Living Space**Entry foyer Living Space**

1. Acceptable **Ceiling:** Plaster, painted
2. Acceptable **Walls:** Drywall, wallpaper
3. Acceptable **Floor:** Ceramic tile
4. Acceptable **Doors:** Solid wood entry door
5. Acceptable **Windows:** Non opening wood framed
6. Marginal **Electrical:** 110 VAC outlets and lighting circuits - **A triple light switch box in the foyer has one open spot. This is a potential safety hazard. Recommend installing a cover plate as needed.**
A "mystery switch" was noted in this room. Recommend asking the seller about it's function.
